# Erecting Open Web Steel Joists

## One of the Deadly Dozen Hazardous Activities

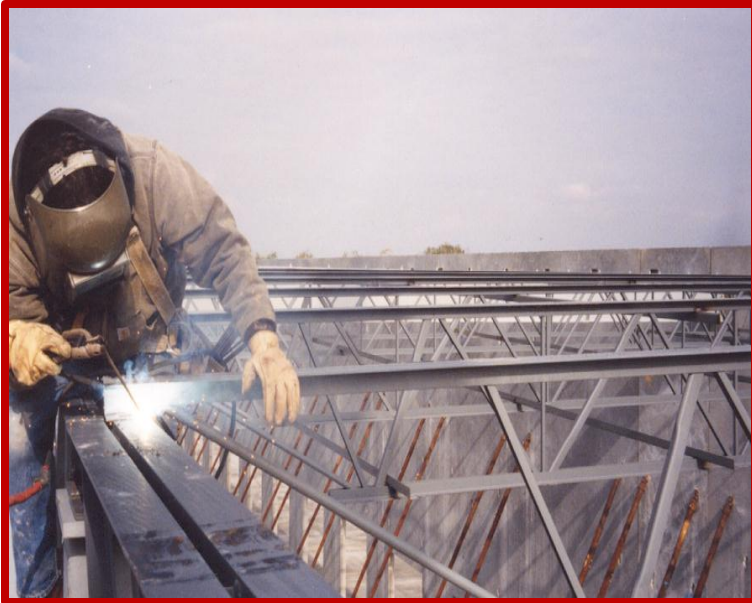
**Requirements for Securing Joist Ends to Prevent Displacement Hazards** – One of the primary causation factors in many serious incidents and fatalities has been attributed to the failure to adequately secure the joist ends to the structure.

**OSHA 1926 757(b)(3)**- “except when panels that have been pre-assembled from steel joists with bridging, each steel joist shall be attached to the support structure, at least at one end on both sides of the seat, immediately upon placement in the final erection position and before additional joists are placed.”

When joist ends are not secured (bolted or welded) to the supporting beam or joist girder upon final placement, hazards pertaining to accidental displacement exists. Ironworkers traveling from point to point or dragging welding lead over the unsecured joists can easily cause the joist ends to slide, lose bearing and collapse to the ground or next lower level below.

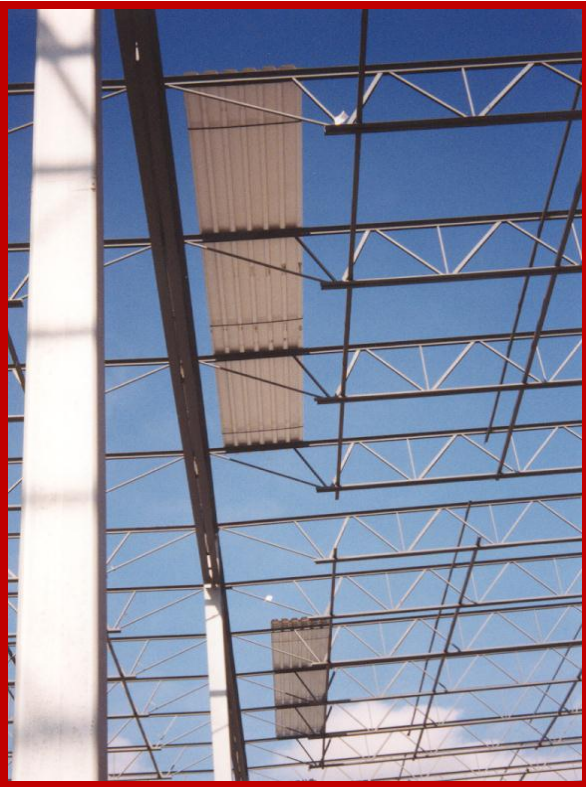
This OSHA standard requires both the steel joist shoe and the beam to be fabricated with holes to allow for field bolting.

**The OSHA 1926 757(a)(8)** requires “(i) except for steel joists that have been pre-assembled into panels, connections of individual steel joists to steel structures in bays of 40 feet or more shall be fabricated to allow for field bolting during erection. (ii) These connections shall be field-bolted unless constructability does not allow.”

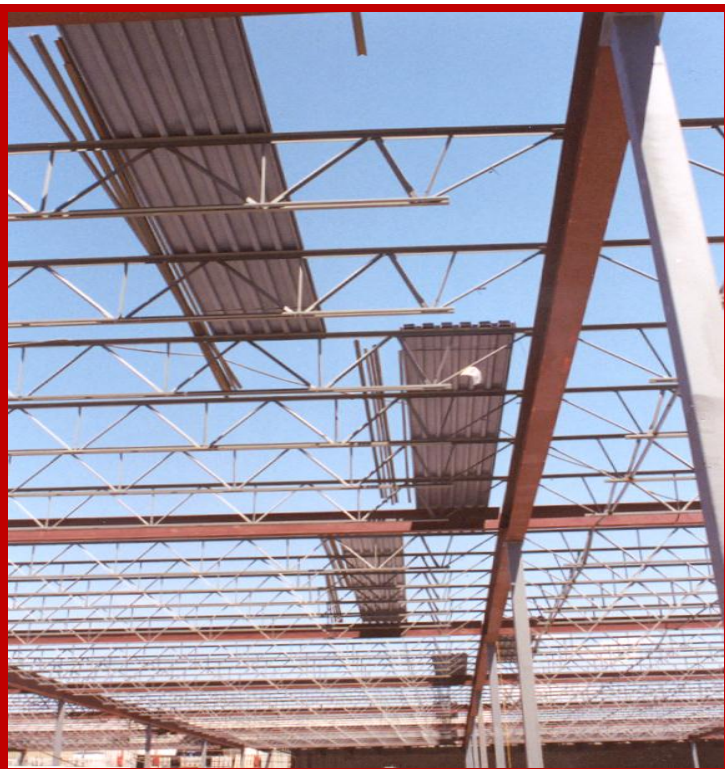
When certain job site conditions are met, bundles of decking may be landed or placed on joists that are not fully bridged provided that the following six special conditions are met:

1. The employer has first determined from a qualified person and documented in a site-specific erection plan that the structure or portion of the structure is capable of supporting the load;
2. The bundle of decking is placed on a minimum of 3 steel joists;
3. The joist supporting the decking are attached at both ends;
4. At least one row of bridging is installed and anchored;
5. The total weight of the bundle of decking does not exceed 4,000 pounds; and
6. Placement of the bundle of decking shall be in accordance with paragraph (e)(5) of 1926.757.

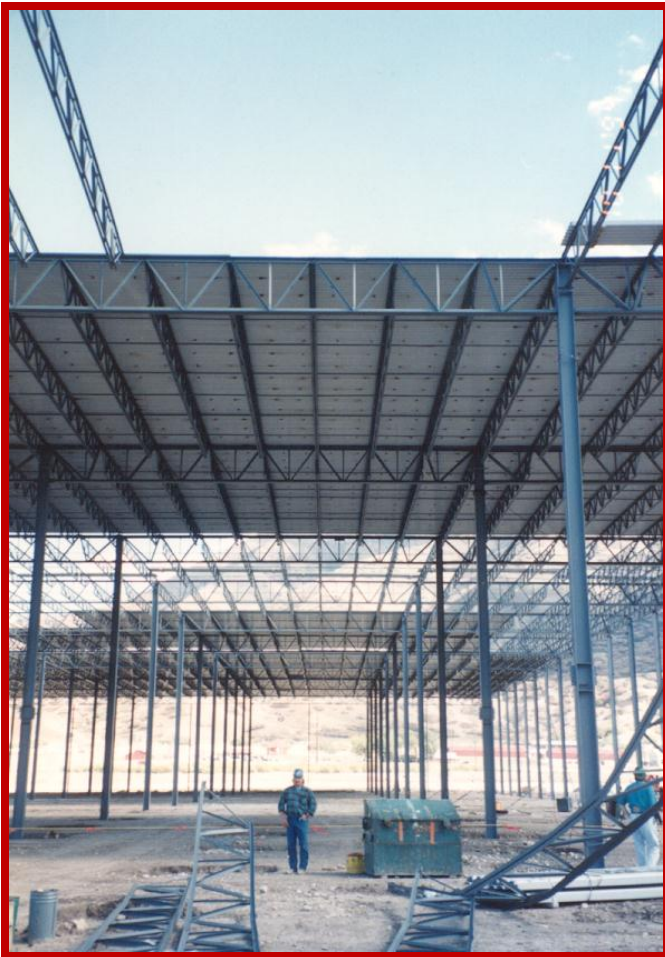
The photograph on the left illustrates several serious hazards and OSHA violations. The steel joists were loaded with bundles of metal roof decking and horizontal bridging prior to the joist ends being secured and bridging installed. Additionally, the decking bundles were not placed within 1 foot of the bearing surface of the joist end. This can cause the unsecured joist to either shift or sprawl under loading. This jobsite was a fast-track project where many Ironworkers were accessing unsecured joists and shaking-out horizontal bridging. Serious accidents involving structural collapse can occur if the open web steel joists are not adequately secured prior to landing deck bundles, bridging bundles, or other construction materials. Ironworkers must never access joists unless all the above conditions are met.
