## Rebar Column and Wall Collapse One of the Deadly Dozen Hazardous Activities

### **Recognizing and Avoiding Column Stability Hazards**

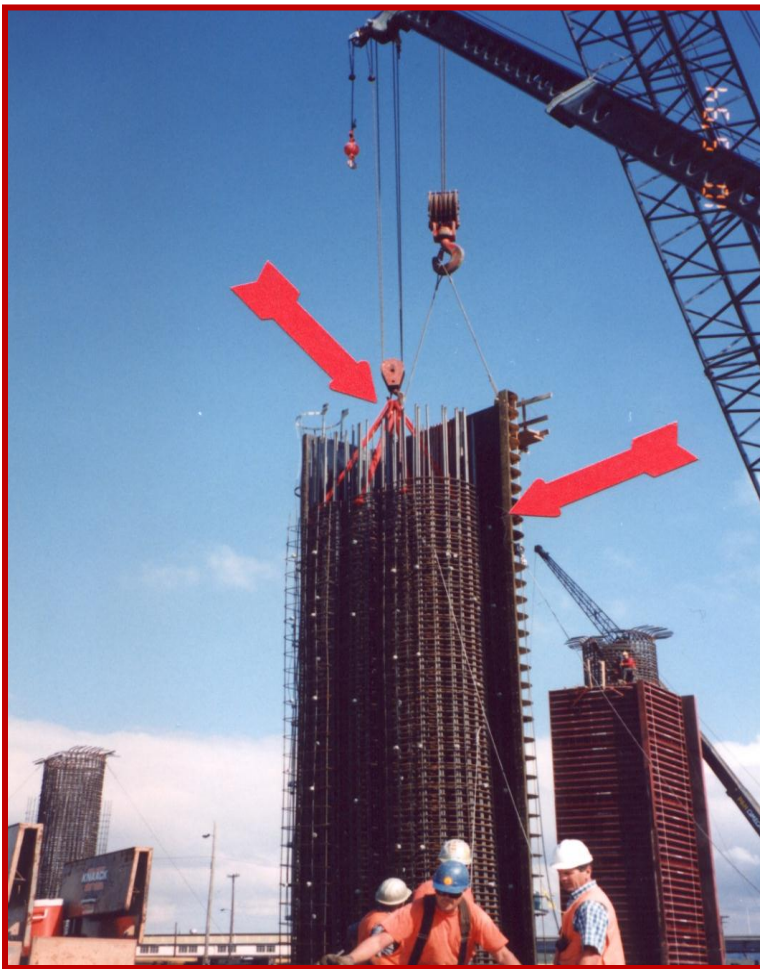
Structural collapse of rebar columns have resulted in fatalities and disabling injuries to our members throughout the United States and Canada. Incident investigation reports indicate some of the primary causation factors have been the lack of sufficient guying and bracing. While the demand for poured in place rebar columns in buildings and bridges continues to increase, unfortunately the structural collapse of large single, double, and triple barrel rebar columns has also increased. Additionally, one of the contributing factors that remain a common denominator is the lack of clear regulatory responsibility for the design, installation, and removal of rebar column guying or bracing systems to provide adequate support. In many cases, it was discovered other trades on the jobsite prematurely removed column support guys to install formwork. Unfortunately, these situations lead to rebar column collapse and serious incidents. Some State Approved OSHA

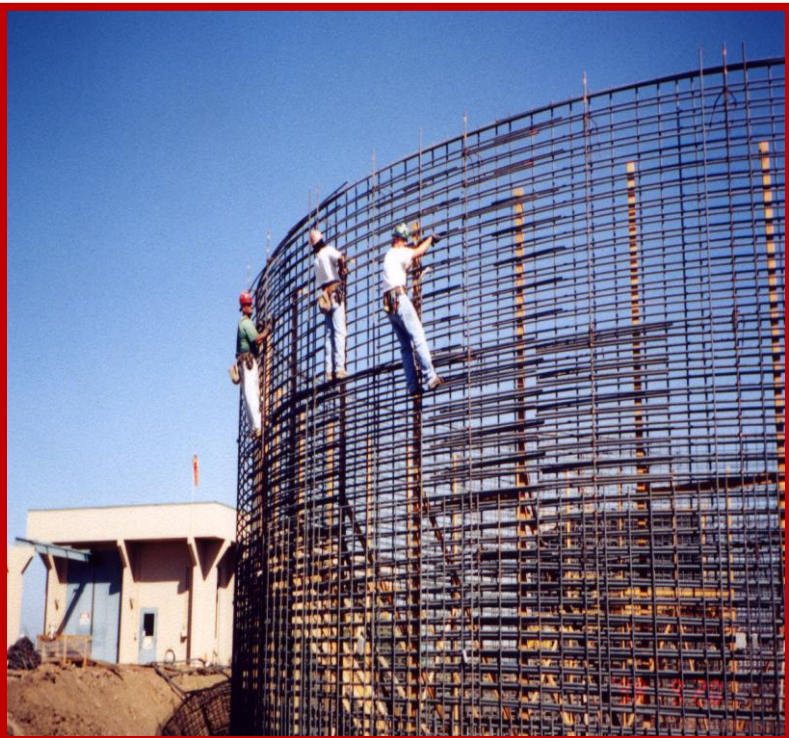
### **Primary Considerations for Maintaining Curtain Wall Stability**

- Temporary bracing systems must be designed by a “qualified person.”
- The proper quality of pipe braces, 2x6 bracing, and any structural support materials must be made available on the jobsite prior to commencement of curtain wall fabrication.
- Ground anchorage points for bracing systems must be pre-determined and capable of sustaining eccentric loading during and after the final fabrication of curtain wall sections.
- The installation and removal of various types of bracing systems must be under the supervision of a “competent person.”
