Rebar Column and Wall Collapse One of the Deadly Dozen Hazardous Activities

Recognizing and Avoiding Column Stability Hazards

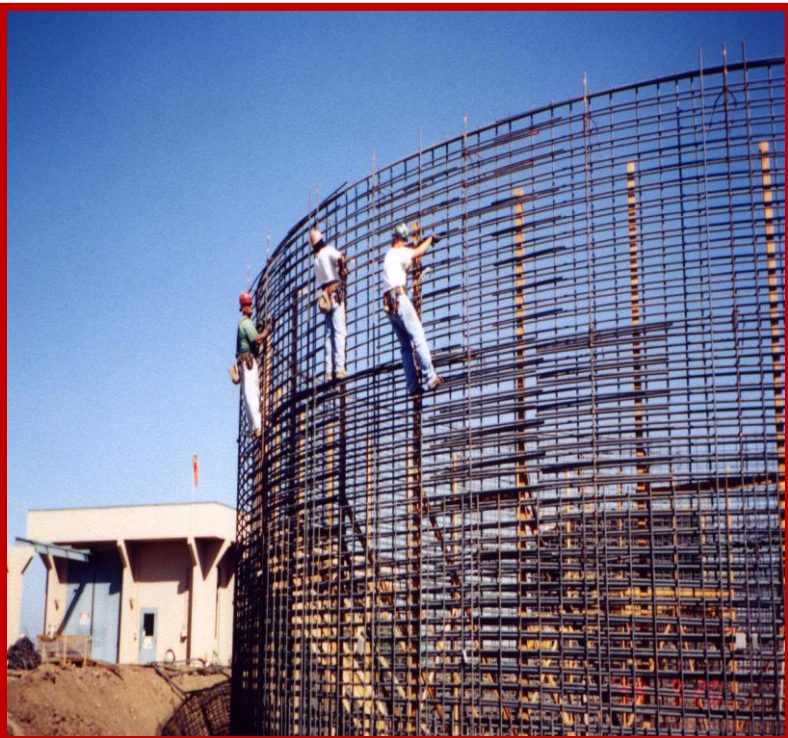
Recognizing and Avoiding Curtain Wall Stability Hazards - In some instances, vertical curtain walls are built in place on the jobsite prior to the placement of formwork. Serious incidents involving structural collapse of vertical rebar curtain walls has been attributed to the lack of adequate bracing and preplanning. Double curtain wall sections can weigh several tons when completed, and maintaining structural stability during erection is one of the primary hazards that must be addressed.

- Temporary bracing systems must be designed by a “qualified person.”
- The proper quality of pipe braces, 2x6 bracing, and any structural support materials must be made available on the jobsite prior to commencement of curtain wall fabrication.
- Ground anchorage points for bracing systems must be pre-determined and capable of sustaining eccentric loading during and after the final fabrication of curtain wall sections.
- The installation and removal of various types of bracing systems must be under the supervision of a “competent person.”

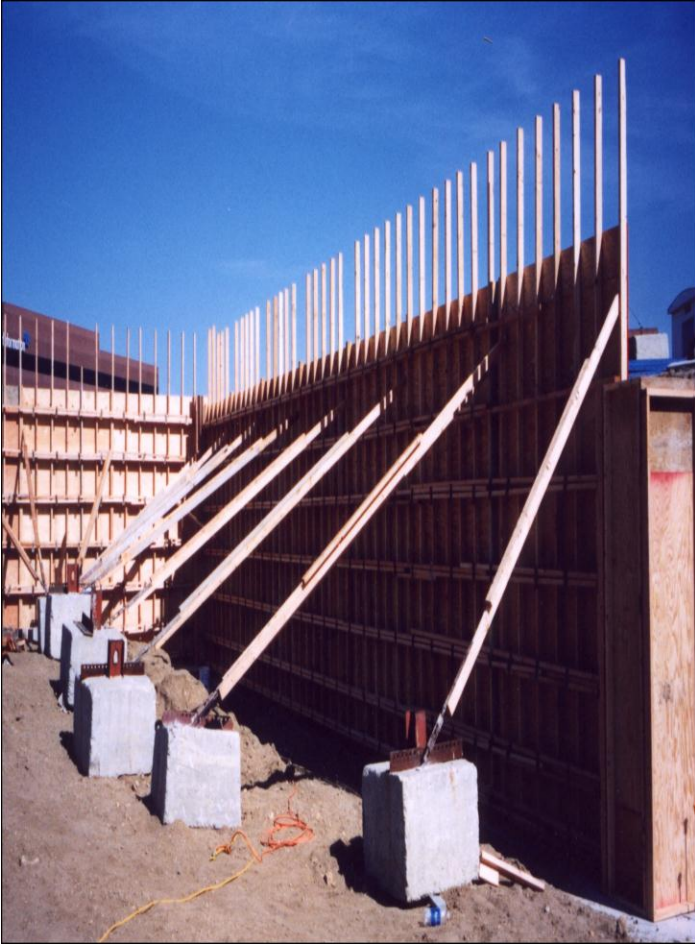
Recognizing and Avoiding Formwork Stability Hazards - Typically, the controlling contractor or other formwork subcontractors will install the concrete formwork prior to the installation of vertical curtain wall steel. Serious incidents resulting in fatalities and disabling injuries continue to occur due to the lack of specific requirements and responsibilities pertaining to formwork stability. In many cases, our members arrive to the jobsite and are unaware of the structural integrity the formwork. Accelerated pour schedules and “fast track” formwork erected by other subcontractors can create structural collapse hazards for our reinforcing Ironworkers when proper bracing and formwork inspection is not performed. Our Ironworkers should not be in the position to evaluate the structural integrity of formwork installed by other parties on the jobsite. This responsibility must be performed by the controlling contractor or other formwork subcontractors who install the formwork on the jobsite.
